LUMOS TEST REPORT

FM 4473 IMPACT RESISTANCE TESTING OF VISION MODULE SYSTEM, TYPE L AND S

S1476.01-801-44 R0

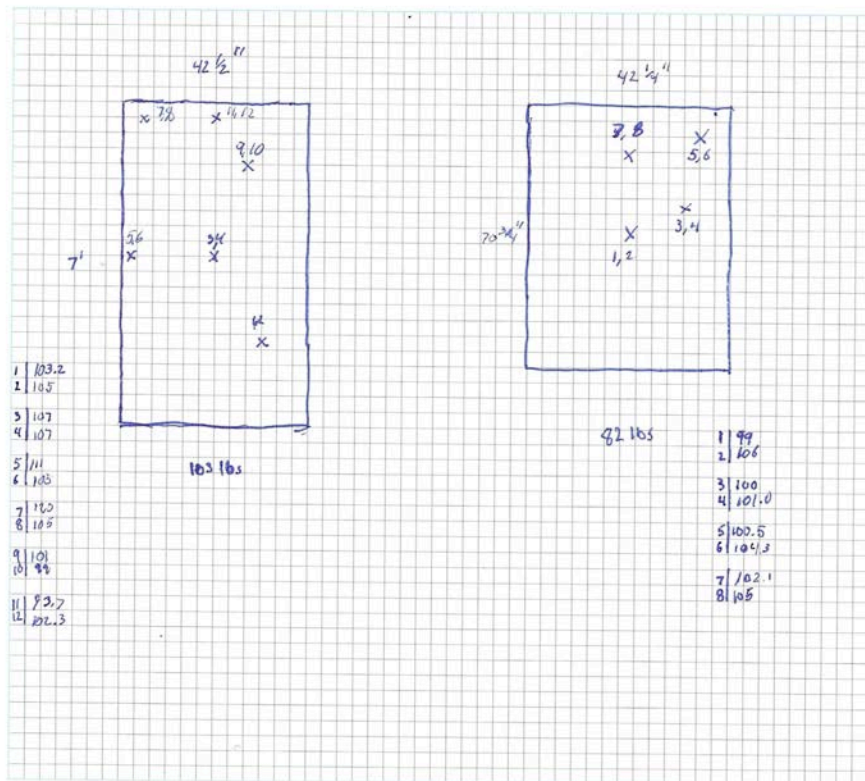
Sketch No. 1 Brief Description

Test Data Sheet

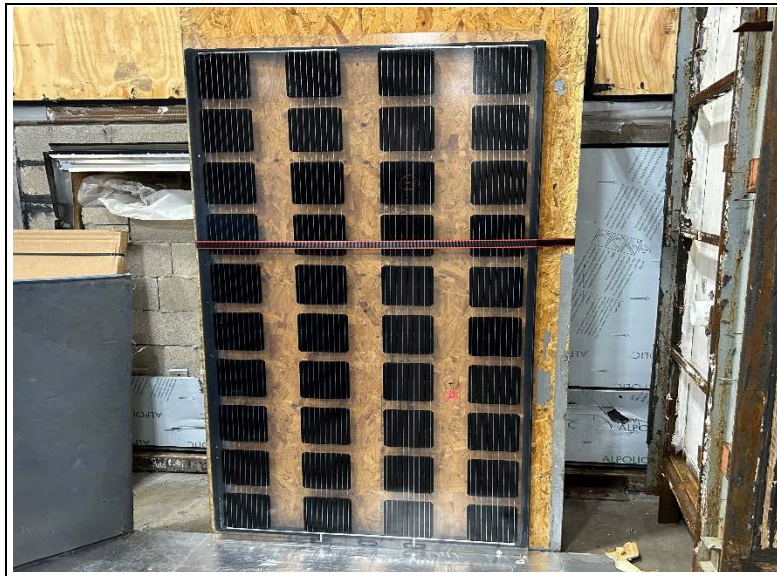
Photo No. 1
Test Unit #1

Test Unit #1

Series/Model: Vision Module System, L Type

Test Unit #1

IMPACT	MISSILE VELOCITY m/s (fps)	ORIENTATION	WEIGHT g (lbs)	DIAMETER mm (in.)	ENERGY ft-lb	IMPACT AREA	OBSERVATIONS	RESULTS
1	31 (103)	Vertical	64.0 (0.141)	50.8 (2.0)	23.27	Lower right	No visible cracking or breakage	Pass
2	32 (105)	Vertical	63.5 (0.140)	50.8 (2.0)	23.99	Lower right	No visible cracking or breakage	Pass
3	33 (107)	Vertical	63.0 (0.139)	50.8 (2.0)	24.72	Center	No visible cracking or breakage	Pass
4	33 (107)	Vertical	63.5 (0.140)	50.8 (2.0)	24.91	Center	No visible cracking or breakage	Pass
5	34 (111)	Vertical	63.5 (0.140)	50.8 (2.0)	26.81	Left middle	No visible cracking or breakage	Pass
6	32 (105)	Vertical	63.5 (0.140)	50.8 (2.0)	23.99	Left middle	No visible cracking or breakage	Pass
7	37 (120)	Vertical	63.0 (0.139)	50.8 (2.0)	31.09	Upper left corner	No visible cracking or breakage	Pass

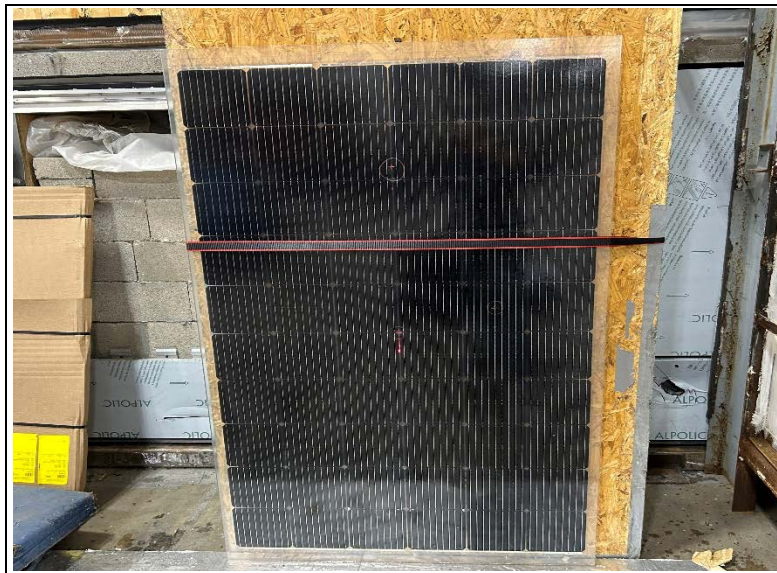
Photo No. 2
Test Unit #2

Test Unit #2

Series/Model: Vision Module System, S Type

Test Unit #2

IMPACT	MISSILE VELOCITY m/s (fps)	ORIENTATION	WEIGHT g (lbs)	DIAMETER mm (in.)	ENERGY ft-lb	IMPACT AREA	OBSERVATIONS	RESULTS
1	30 (99)	Vertical	63.5 (0.140)	50.8 (2.0)	23.08	Center	No visible cracking or breakage	Pass
2	32 (106)	Vertical	63.5 (0.140)	50.8 (2.0)	23.99	Center	No visible cracking or breakage	Pass
3	31 (100)	Vertical	67.5 (0.149)	50.8 (2.0)	23.13	Right middle, on solar cell	No visible cracking or breakage	Pass
4	31 (101)	Vertical	64.5 (0.142)	50.8 (2.0)	22.55	Right middle, on solar cell	No visible cracking or breakage	Pass
5	31 (101)	Vertical	63.5 (0.140)	50.8 (2.0)	22.20	Upper right corner	No visible cracking or breakage	Pass
6	32 (104)	Vertical	66.0 (0.146)	50.8 (2.0)	24.46	Upper right corner	No visible cracking or breakage	Pass
7	31 (102)	Vertical	63.0 (0.139)	50.8 (2.0)	22.46	Upper middle, on rail	No visible cracking or breakage	Pass
8	32 (105)	Vertical	64.5 (0.142)	50.8 (2.0)	24.37	Upper middle, on rail	No visible cracking or breakage	Pass
